ROPS mounting feet

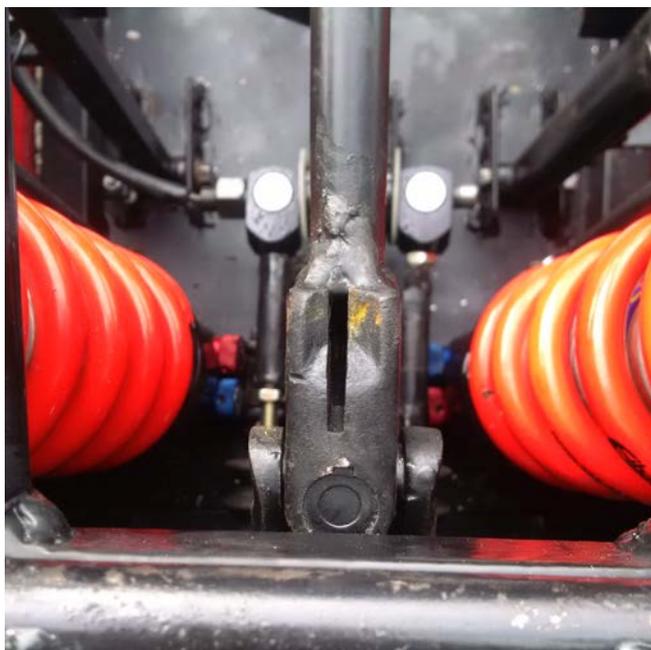
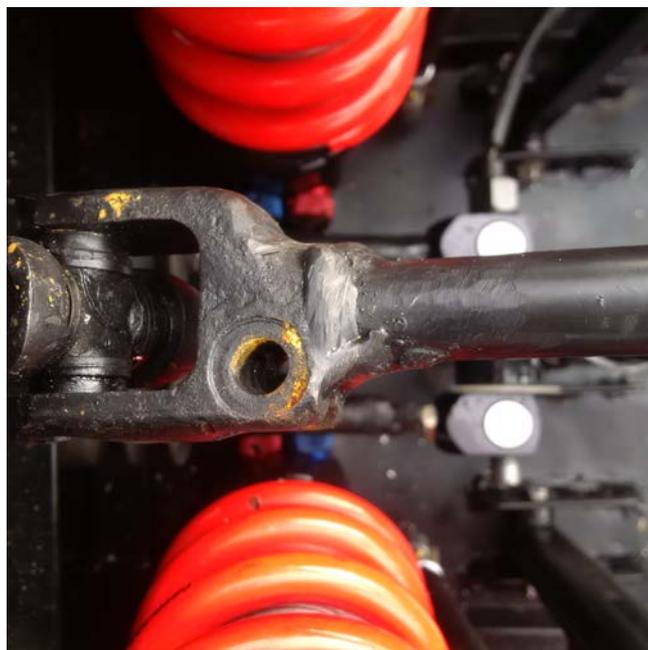
Steering column

We are constantly impressed by what our Scrutineers pick up during routine Scrutineering inspections! This example of a steering rack/column from a single seater was recently presented for scrutineering, the Scrutineer spotted that the steering shaft does not actually enter the Universal Joint, the connection is totally reliant on a weld between the joint and the shaft. As the Scrutineer points out this is not a good idea where you have a steel shaft and cast Universal Joint.

This is another good example of the potential issues that can be seen by just taking a general look over the vehicle during your routine scrutineering, the competitor can then be advised accordingly to rectify such issues.

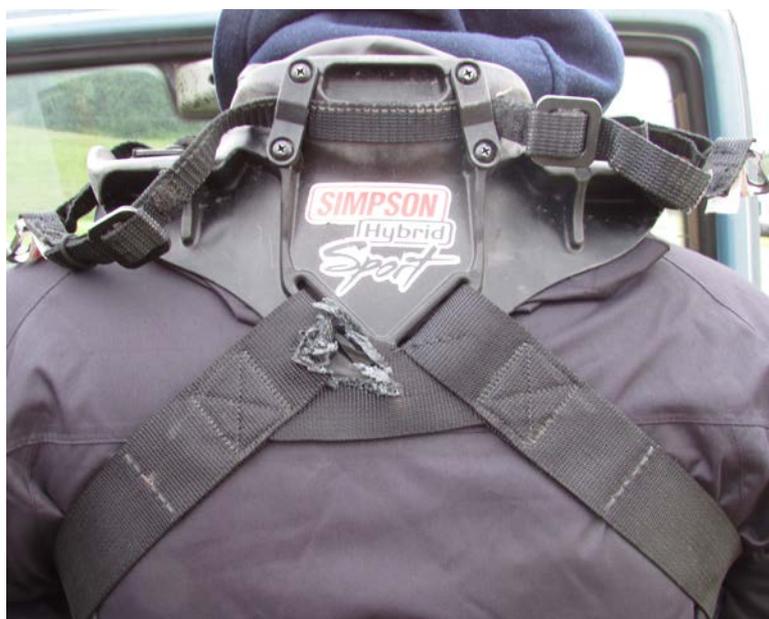
FHR damage

The photo here was forwarded to us recently by a Scrutineer who was presented with this very obviously damaged *Simpson* FHR at pre-event scrutineering for a Cross Country event – with the previously applied MSA FHR sticker already removed and the 'void' markings clearly showing! When questioned, the navigator explained that the damage was caused by a running drive-belt when he had crawled under the vehicle during a previous event, after stopping on course and attempting to attempt to fix a steering issue. So – as the scrutineer pointed out – not only protecting the neck, but the back as well!

Needless to say, in this condition – with such damage to the webbing straps – this FHR is not suitable for use, and in this case the Scrutineer correctly impounded the item for the duration of the event and the competitor sought out an alternative. It was then returned at the end of the event, with the instruction that it should not reappear at an MSA event!

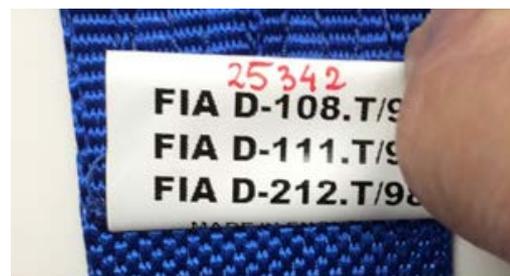
It may also be useful to note that some of the harness manufacturers write or print a reference number on the homologation labels that are sewn into each harness strap. If you find a harness where the reference number is not consistent across all straps you can be pretty sure the harness is not a complete set.

The example shown here (right) is how *Willans* marks its labels. You cannot rely

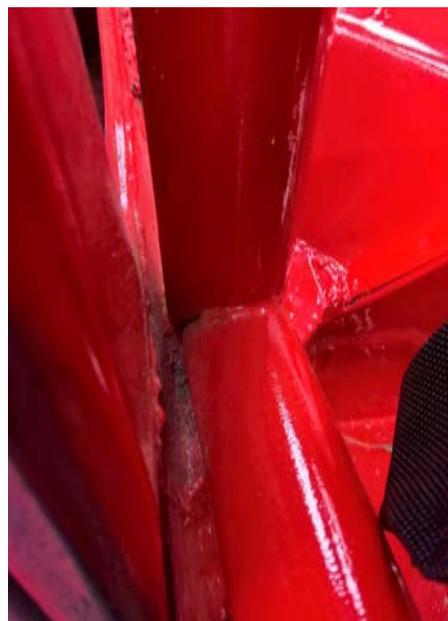
ROPS welding

The photos below were forwarded to us by a Scrutineer who came across this ROPS installed in a car, with the claim that the car has been used for three years with no mention of any concerns. Looking at the photos, you can see that there are incomplete welds in both locations, presumably where these members have been added with the ROPS in situ, and no effort has been made to weld where access is restricted. Regardless of the restriction of access, for any mandatory ROPS member, Scrutineers should be looking for complete full circumference welds of adequate quality.
