Eligibility Training and Assessment

Steering wheel

FHR Sticker Location

Fire Extinguisher

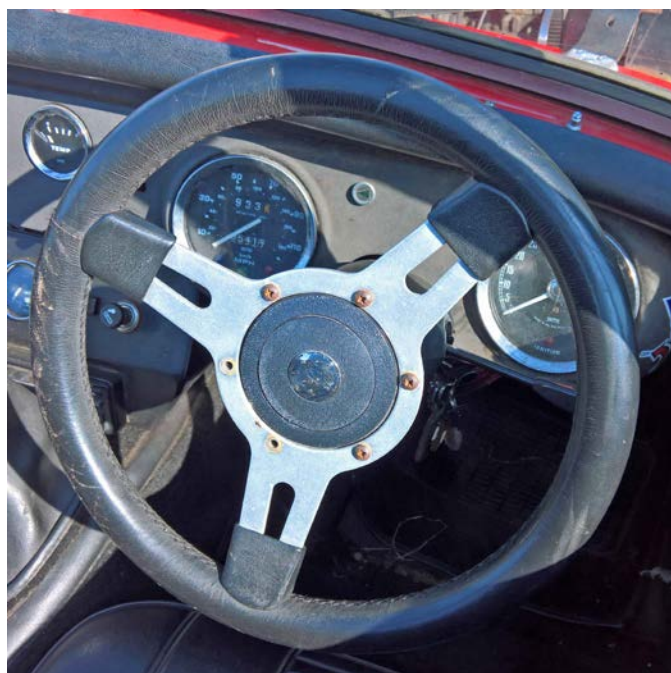
The steering wheel shown on the right was found by a scrutineer at a hill climb event last month.

Of the six bolts that should be holding the steering wheel to the boss, one bolt was completely missing, one bolt had no nut, the screw falling out upon inspection and one bolt was just loose.

The steering wheel security is a fairly easy thing to check, in this case a visual check was all that was needed to see the issue. However, this sort of an obvious preparation issue should make the scrutineer think what else might be amiss and give the car a close look!

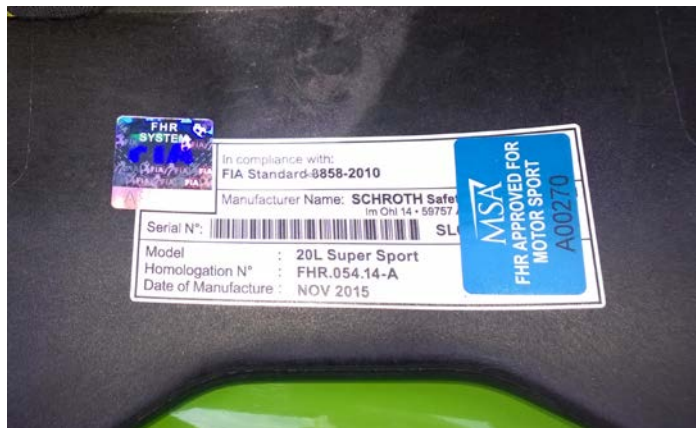
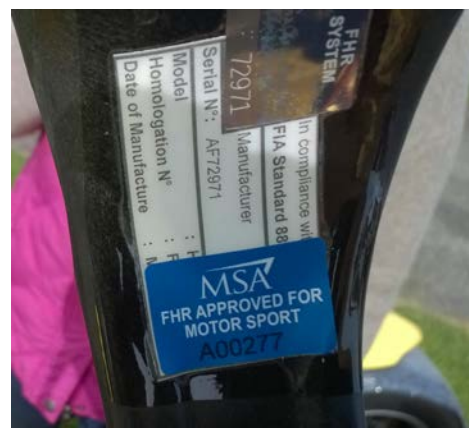
The photos below were sent to us by a scrutineer at a recent hill climb event, both competitors having had their FHR stickers applied at the preceding round of the championship. As you can see the stickers have been applied over the FIA label, in both cases covering up important homologation information displayed on the label.

Please do not cover the FIA label, as any damage or modification of the label will void the homologation of that FHR! As a general principle, the preferred location is adjacent to the FIA standard label in the collar part (image 1), due to limited space it is no issue if the sticker needs to be affixed vertically (image 2).

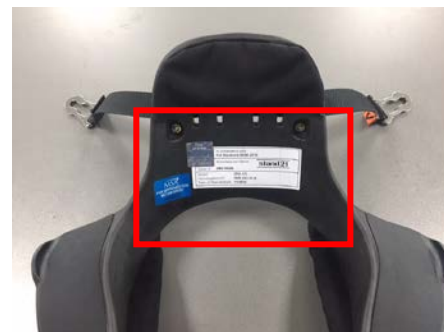
Image 3

On some FHRs, the FIA standard label is under the comfort padding of the over shoulder section of the yoke. In these cases, it is not suitable to affix the sticker in this area as it is not readily visible, instead the sticker should be placed in a suitable location on the collar part, in the general area of the red box shown here (image 3).

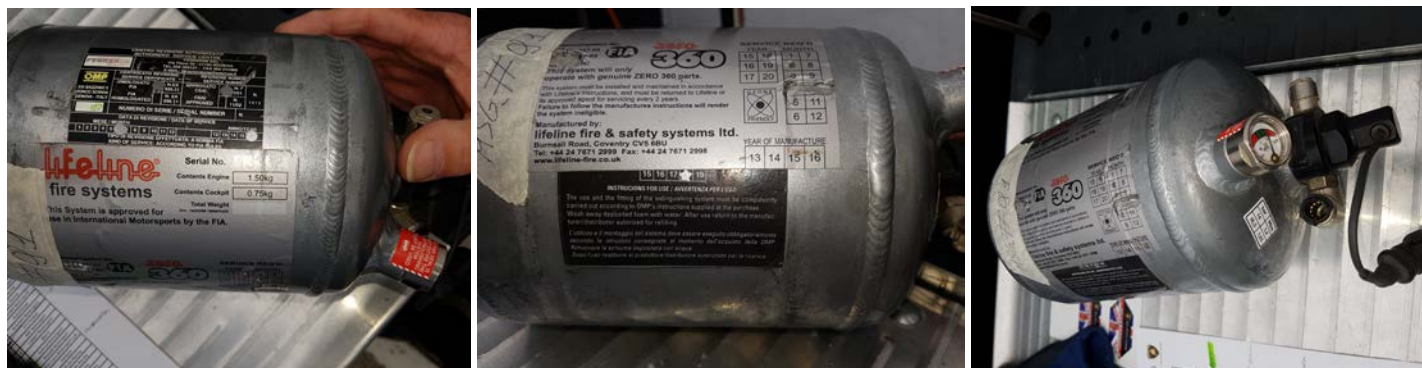
The images below were forwarded to us by a scrutineer, the issue was discovered on a car competing in a visiting International Series. The Scrutineers picked up that the extinguisher did not appear to be correct. After removal from the car for closer inspection the following was found!

An Initial view showed it to be a Lifeline extinguisher, but on closer inspection the lifeline label was stuck on top of an OMP label. The OMP label shows it to be in date (just), whereas the lifeline label was not distinctly marked but appeared to show a February 2018 service date. The lifeline label was shown not to be for this extinguisher bottle as it detailed the extinguishant as Zero 360 gas, whereas the bottle contained AFFF foam!

The International series mandates the use of the OMP AFFF system, and when compared to a new "correct" bottle this extinguisher was found to be 0.5kg lighter, despite the gauge showing correct pressure. This is another example of the scrutineers being vigilant, and developing a "nose" for what is correct or not.

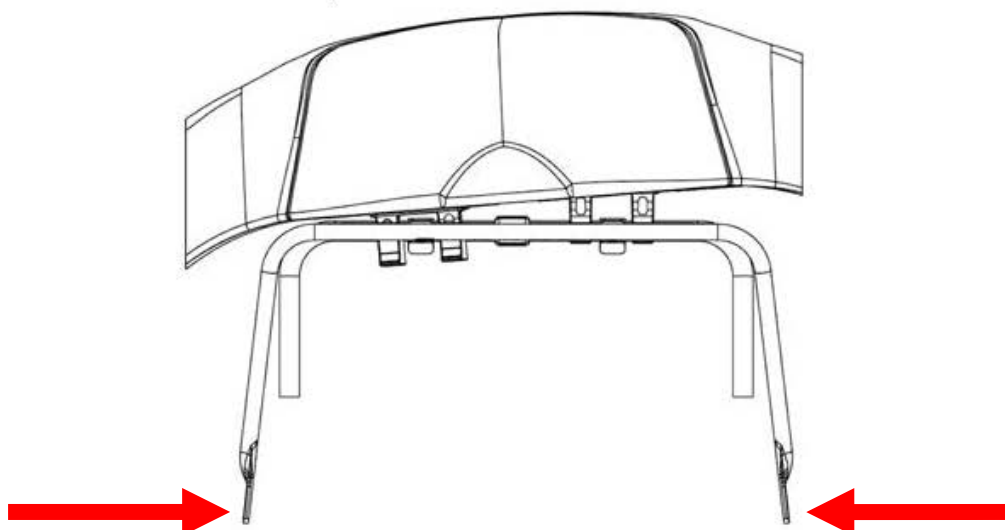
We would like to ask Kart Scrutineers to pay particular attention to ensuring that bumper tubes are securely bolted to the chassis. We have had reports of a few instances where the bolts that secure the top rail of the bumper bar to the chassis have been deliberately left loose to affect the performance of the detachable front fairing.

The location of the bolts in question are shown on drawing below, if found to be loose scrutineers should ensure that the competitor tightens them securely so there is no movement in the bumper bar.
