ROPS mounting feet

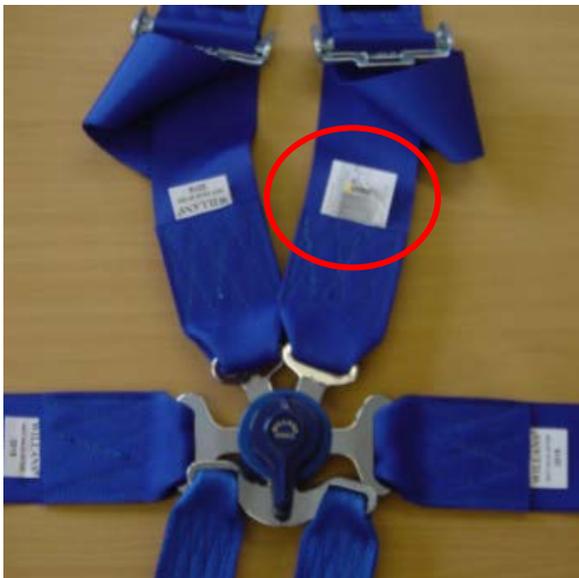
FHR damage

The photo here was forwarded to us recently by a Scrutineer who was presented with this very obviously damaged *Simpson* FHR at pre-event scrutineering for a Cross Country event – with the previously applied MSA FHR sticker already removed and the 'void' markings clearly showing! When questioned, the navigator explained that the damage was caused by a running drive-belt when he had crawled under the vehicle during a previous event, after stopping on course and attempting to attempt to fix a steering issue. So – as the scrutineer pointed out – not only protecting the neck, but the back as well!

Needless to say, in this condition – with such damage to the webbing straps – this FHR is not suitable for use, and in this case the Scrutineer correctly impounded the item for the duration of the event and the competitor sought out an alternative. It was then returned at the end of the event, with the instruction that it should not reappear at an MSA event!
